Manhole Inspection Summary

Manhole # S55AA_009MH

Insp Date: **3/11/10 2:39 PM**

Location Address: **E Monument st**

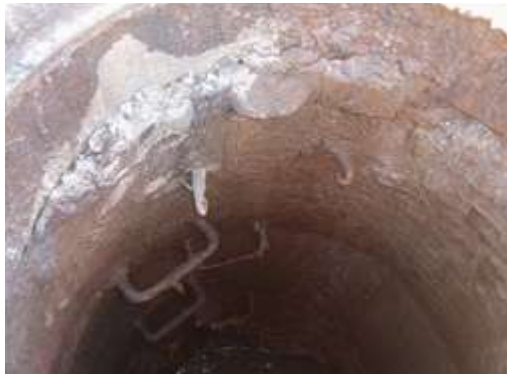
Defect 2

Steps Count: **6** Missing: **1** ☒ **Corroded**

missing step

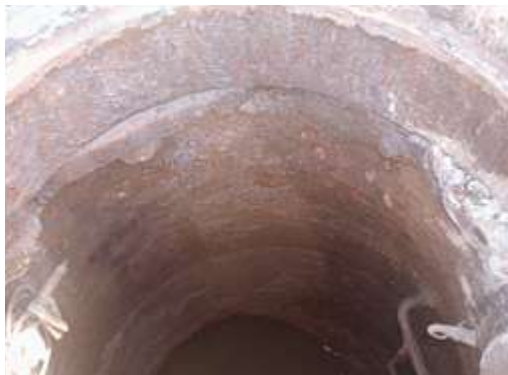
Defect 1

Frame Offset: **1** (in.) Condition: ☐ Sound ☐ Cracked ☒ **Leaks**

Infiltration: ☐ None ☒ **Joint** ☐ Cracks ☐ Mortar ☐ Roots ☒ **Wall**

adjustmentjoint

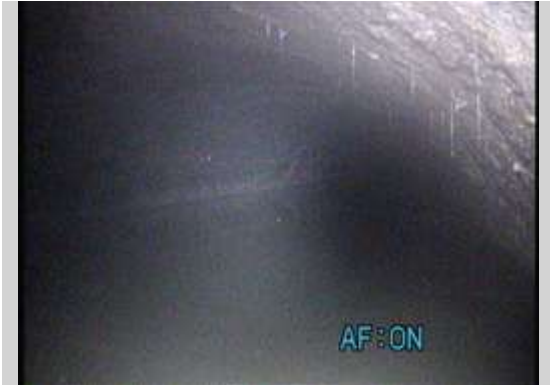
12 O'Clock Outflow

68 in. Circular Gravity Sewer
Pipe Out @ 12 O'Clock

Pipe Height: **75.6** (in.) Rod and Bar (Angled)
Pipe Material: **Unknown** ☐ Pipe Lined
Invert Depth: **14.25** (ft.) Flow Characteristics: **Fast**
Deposits: ☒ None ☐ Mud ☐ Sludge ☐ Debris ☐ Grease
Silt Depth: (in.) Deposits Extent:
Infiltration: **None** Pipe Seal Cond: **Unknown**
